SITE RECONNAISSANCE
AT
NEW RIVER STORAGE DEPOT (NRSD), VIRGINIA
NOVEMBER 12-14, 1997

Prepared for
U.S. ENVIRONMENTAL PROTECTION AGENCY
REGION III

Prepared by
GANNETT FLEMING, INC.
Harrisburg, Pennsylvania

December 1997

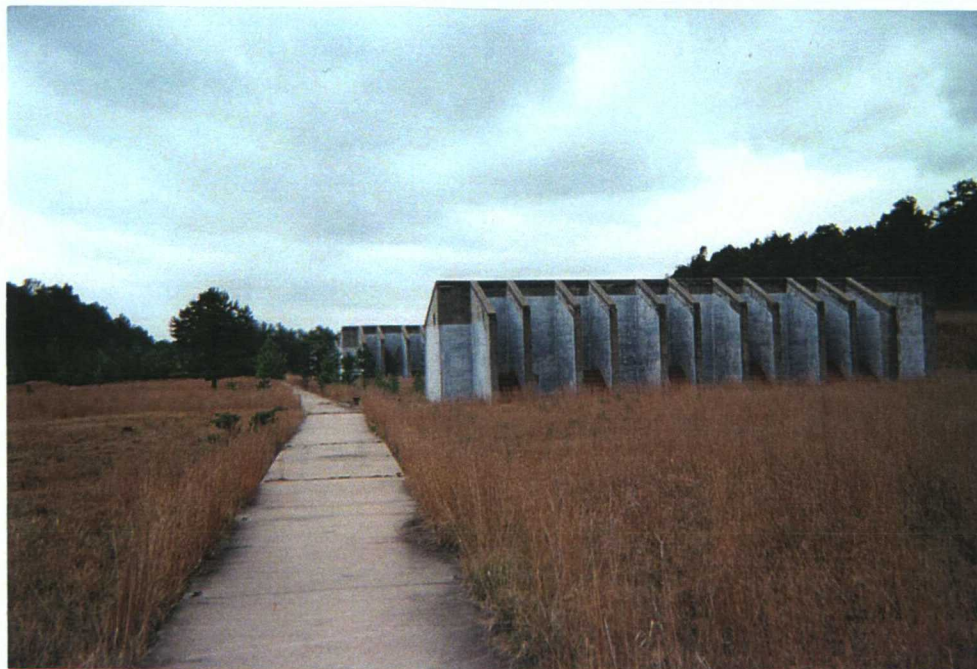
NRSD PHOTO 1: Igniter area showing two flash reducer loading buildings.

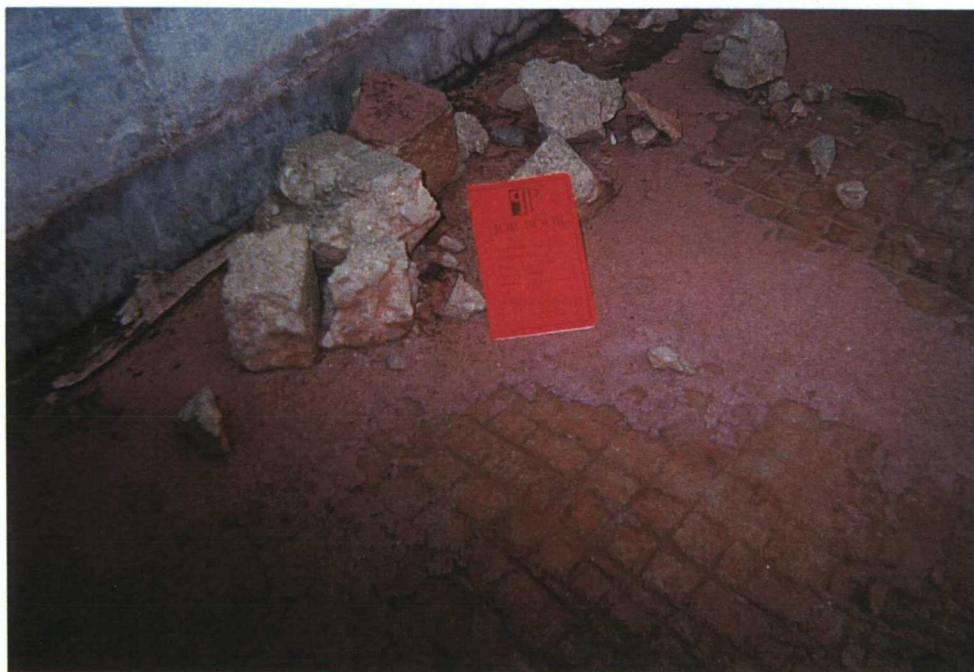
NRSD PHOTO 2: Red conductive floor material at Igniter area.

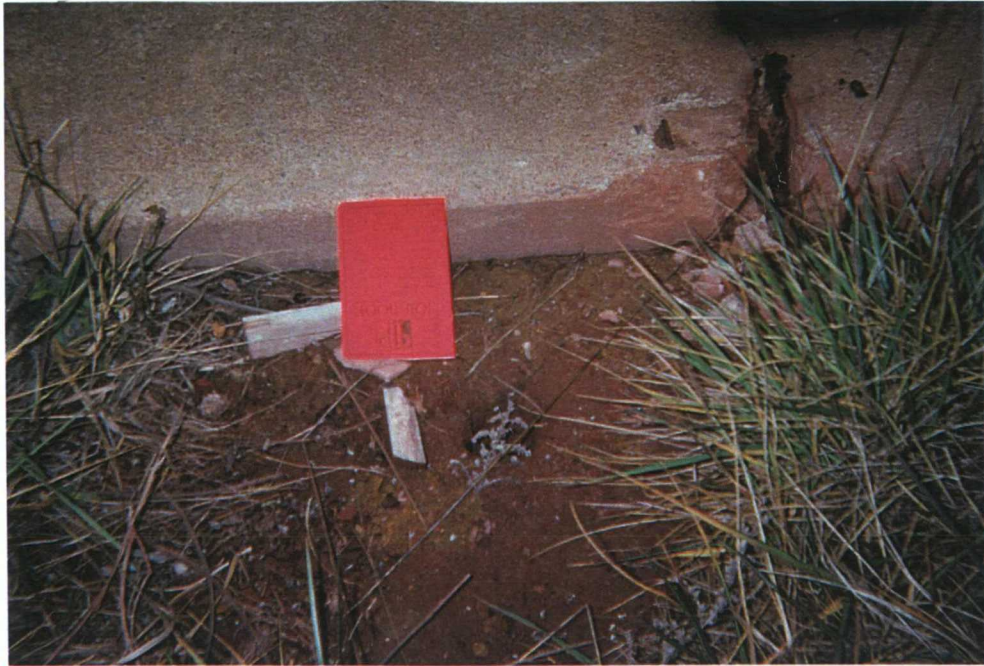
NRSD PHOTO 3: Red conductive flooring material stain on soil surface. Note sample hole #SS-11 from June 1997 sampling event.

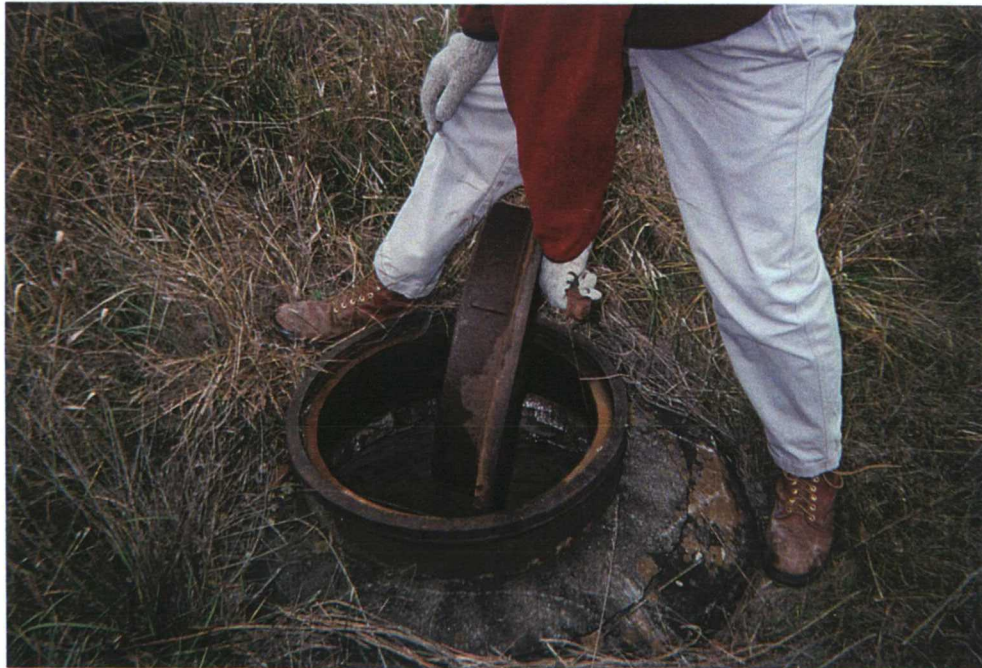
NRSD PHOTO 4: Manhole No. 18 near railroad transfer platforms. Sampling Station SL-05.

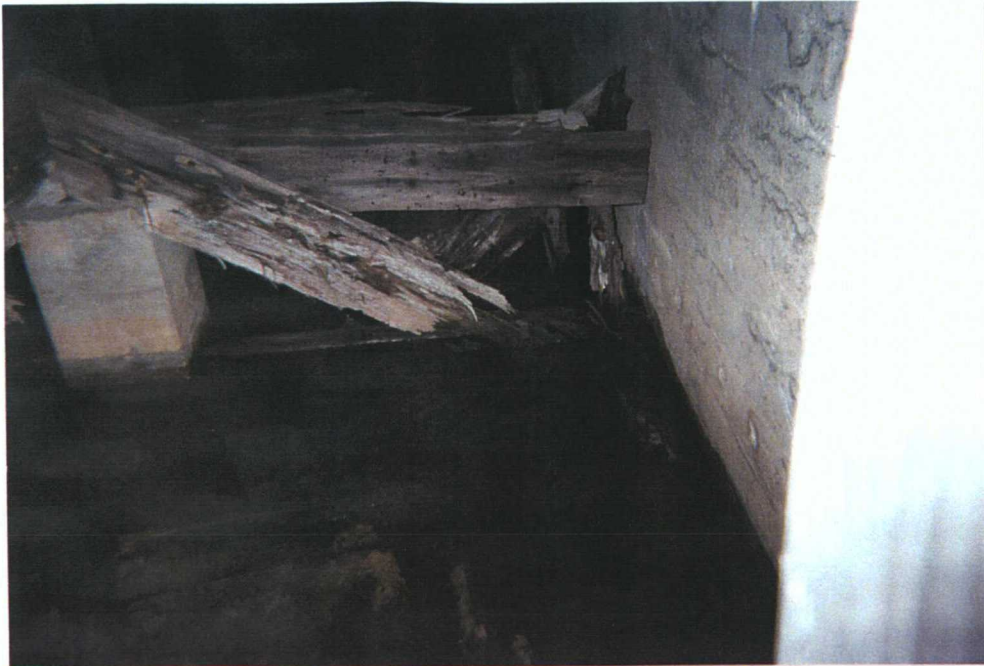
NRSD PHOTO 5: Interior of Transfer Platform 603.

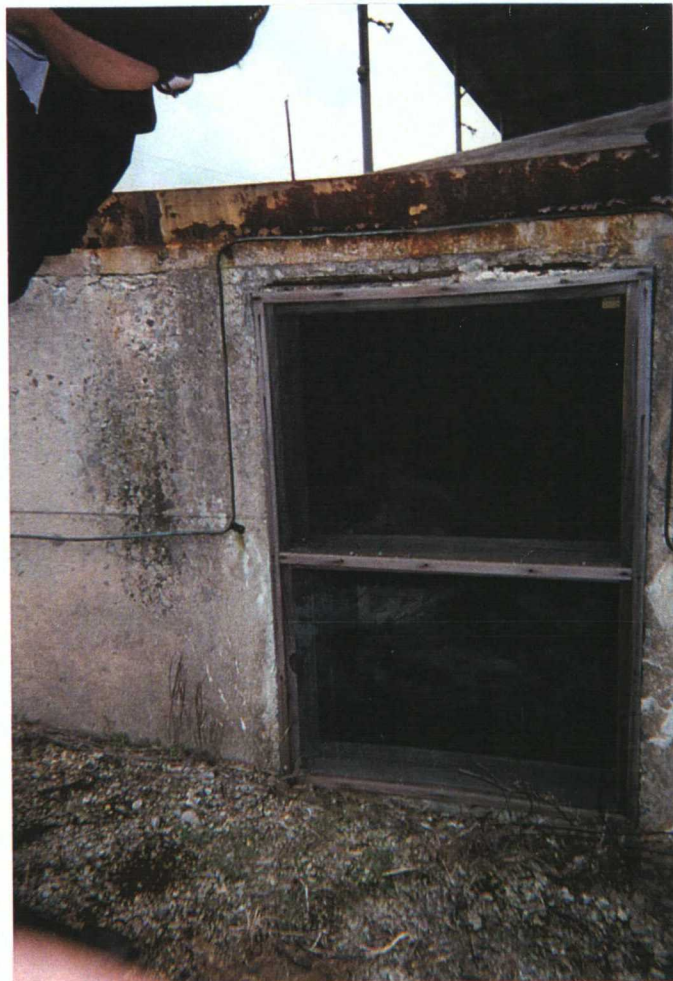
**NRSD PHOTO 6:
Exterior of Transfer
Platform 603.**

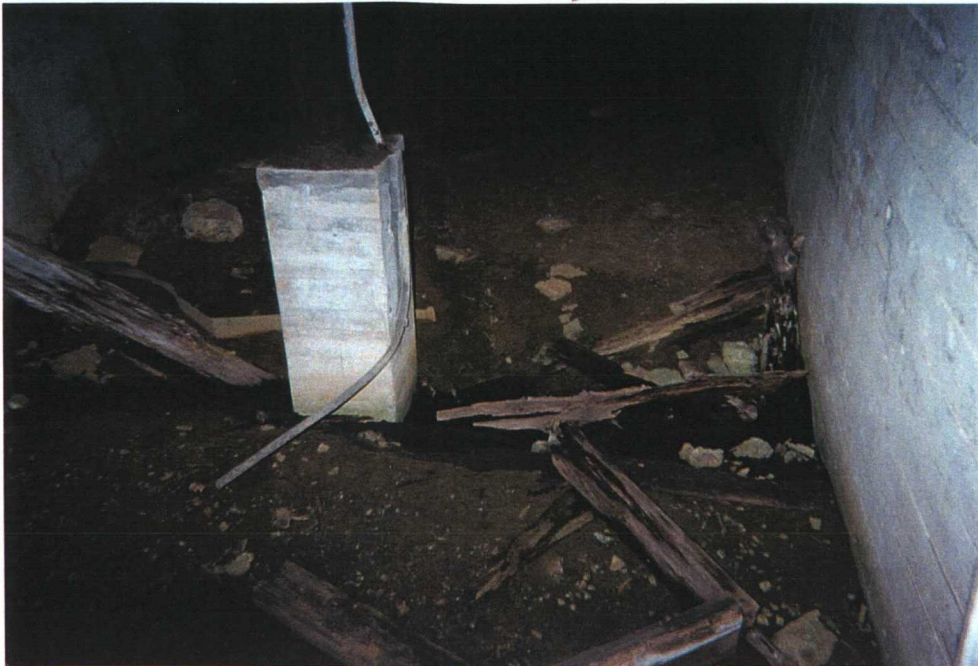
NRSD PHOTO 7: Interior of Transfer Platform 602.

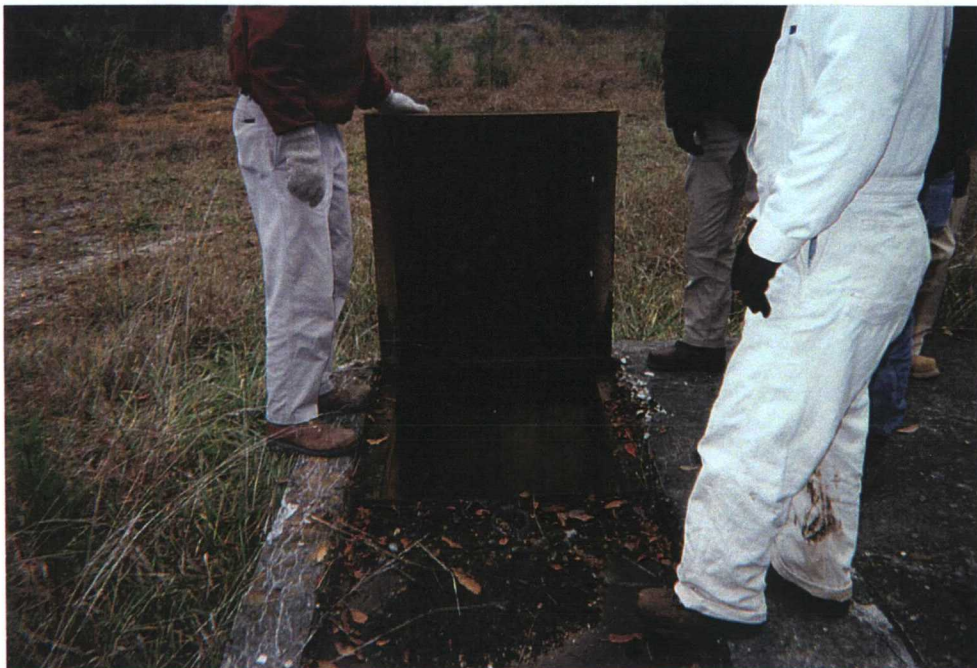
Next, the prototype building area (Area C) was inspected and a sump lid was opened. No changes to this area or the burning grounds were noted since the last site visit.

NRSD PHOTO 8: Phototype building area - sump.

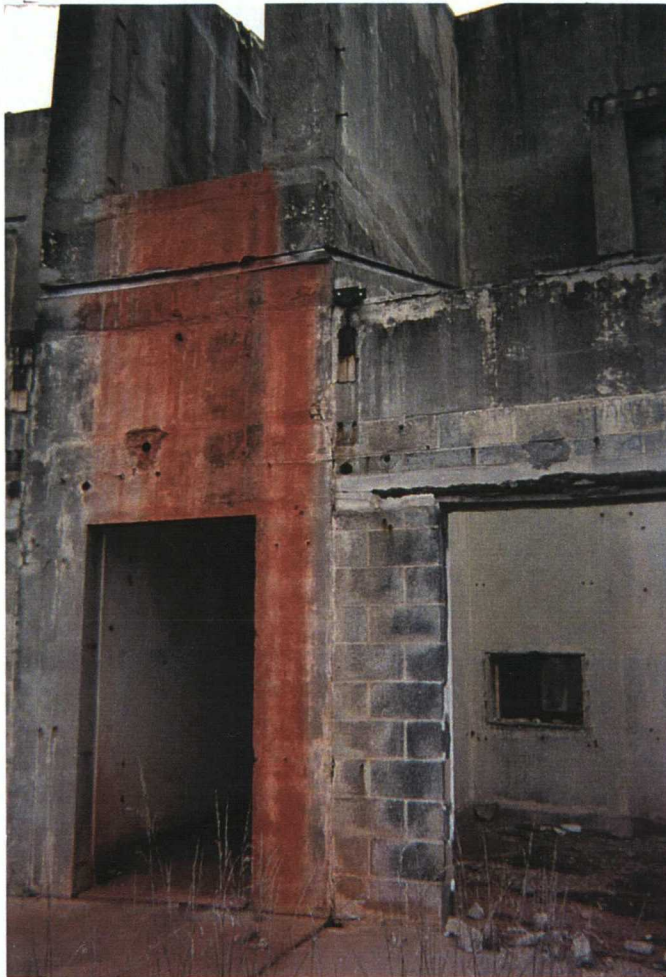
Area E - Bag Loading Building No. 405 was toured. Conductive paint was observed to be running down the side of the building and out onto the ground surface. Areas of Bag Loading Building 405 were noted to have had the roof torn down. The conductive flooring was in varying stages of decay. An elevator shaft was also inspected at the building. It was found to have oil-stained soils at the bottom of the shaft. The soils were reportedly tested previously by the Army and considered to be non-hazardous.

NRSD PHOTO 9:
Building 405 with conductive
paint cascading from the
2nd floor.

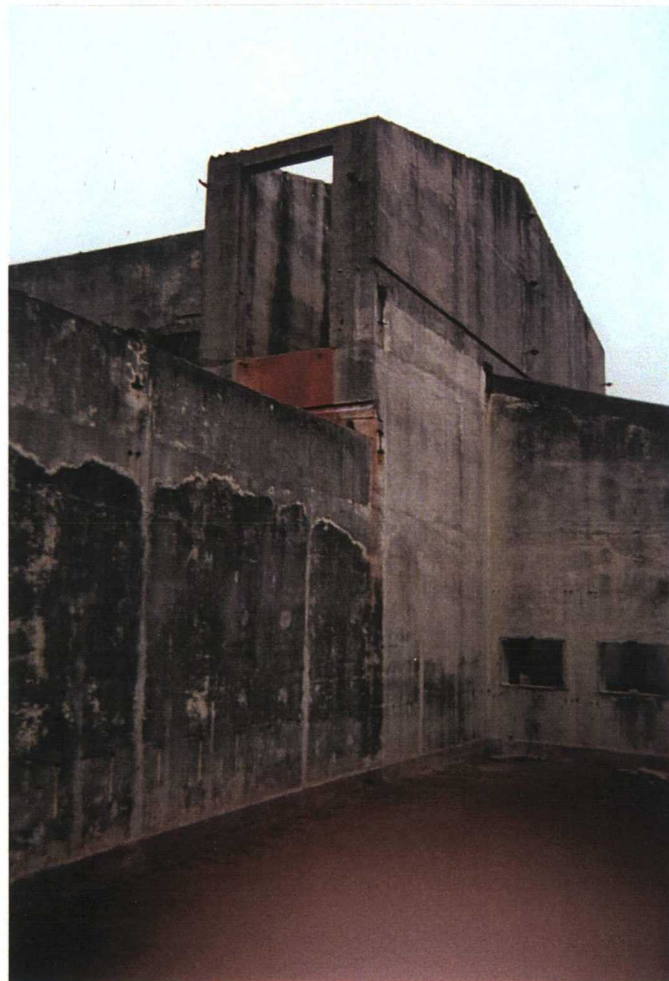
NRSD PHOTO 10:
Bag Loading Building 405
with portion of roof absent -
previously torn down.

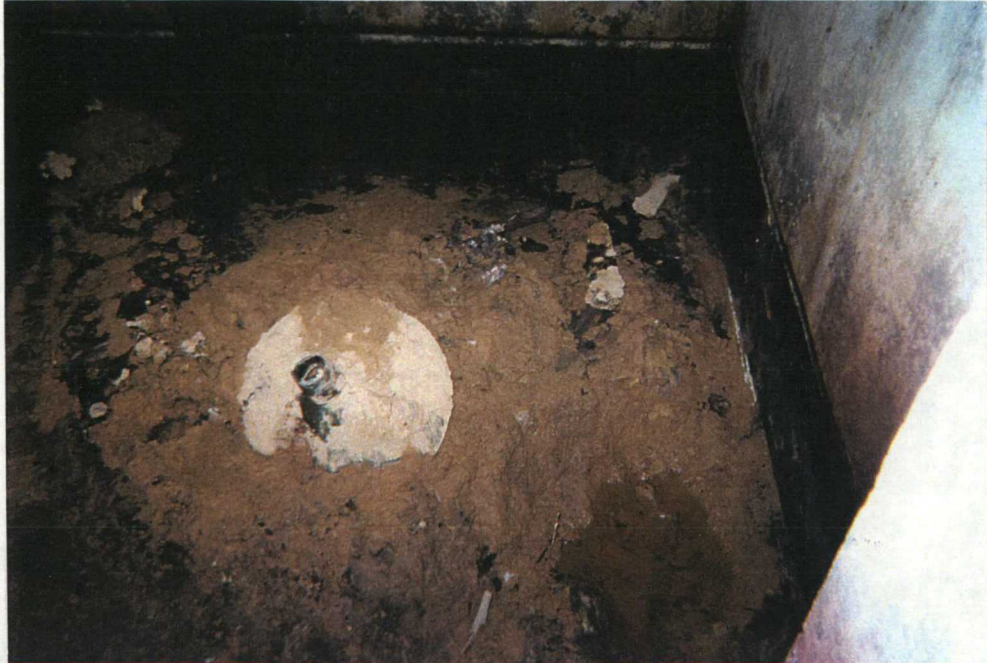
**NRSD PHOTO 11: Abandoned elevator shaft in Building 405.
Note the oil stained soil (previously tested by the Army).**

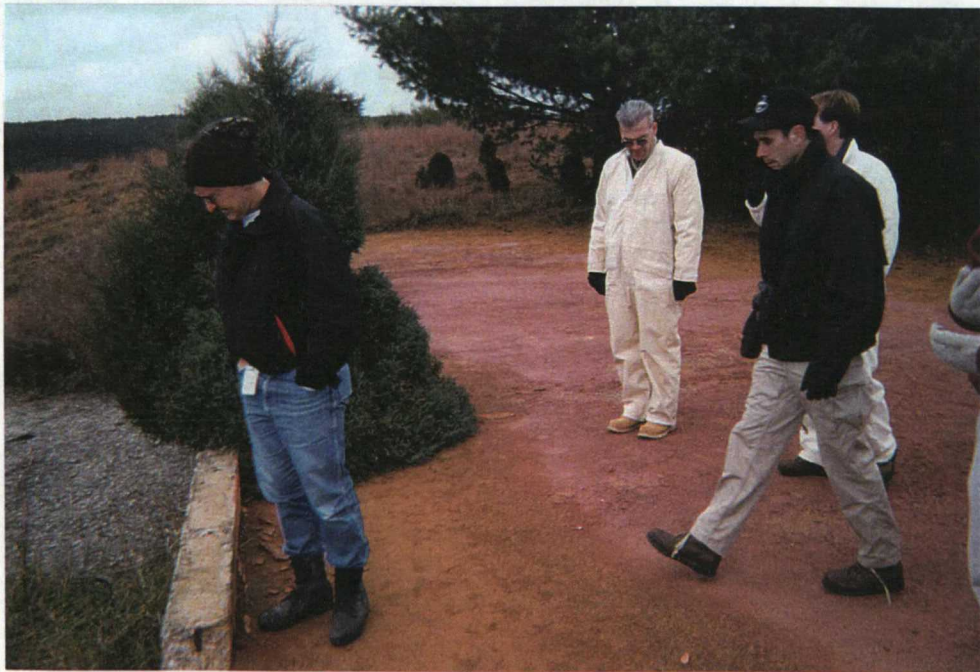
The field team walked from the bag loading buildings to former Building 412, the Container and Shipping Magazine. Only the foundation remains and, as seen in the accompanying Photo No. 12, contains remnants of the red conductive floor material.

**NRSD PHOTO 12: Only the building foundation remains from Building 412.
(The container and shipping magazine for bag loading buildings 404 and 405.)**

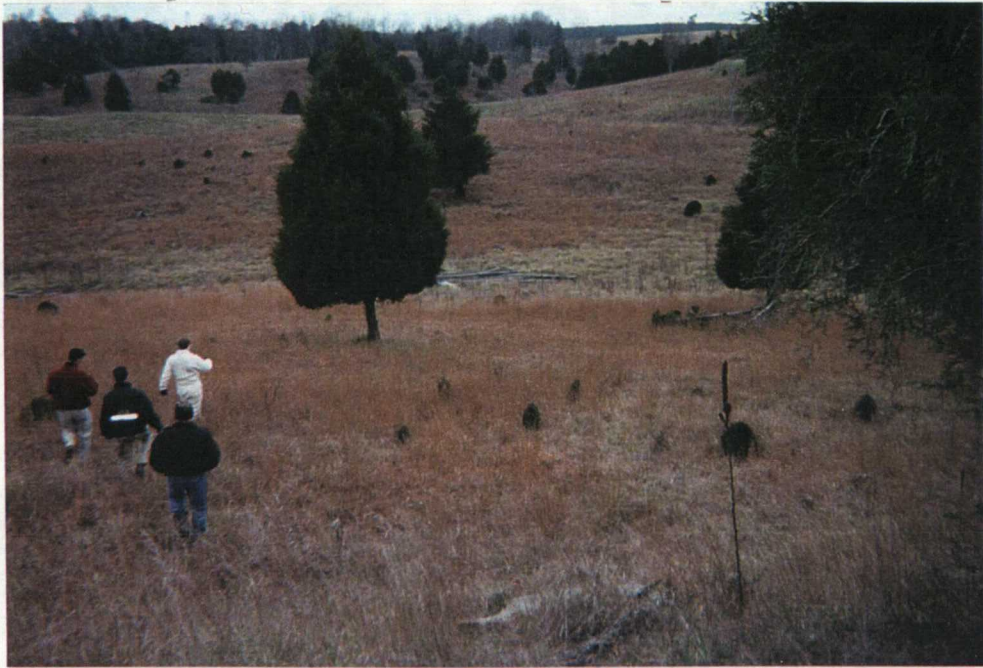
NRSD PHOTO 13: View of small stream from roadway adjacent to High Explosives Magazine 4603-3.

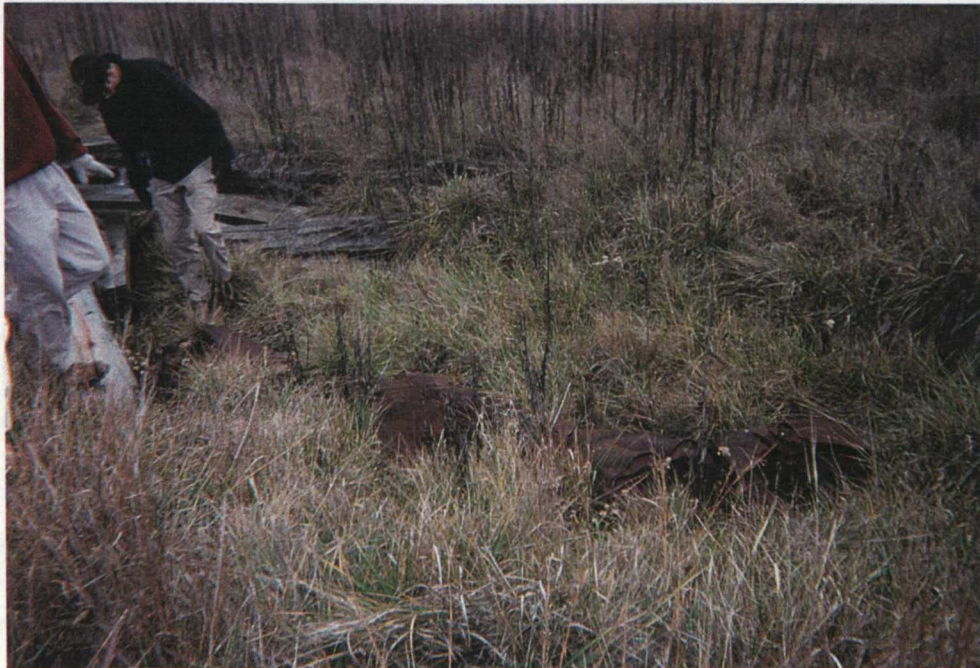
The final area inspected on November 12 is the stream area shown as Area G on the accompanying facility base map and also seen in the USGS map on Figure 2. The small stream, which flows to the east along the southern portion of the facility was found to serve as a dumping area for wood and for drums that were observed to contain a tar-like substance.

NRSD PHOTO 14: Small stream near H.E.M. 4603-3 showing wood and drum debris.

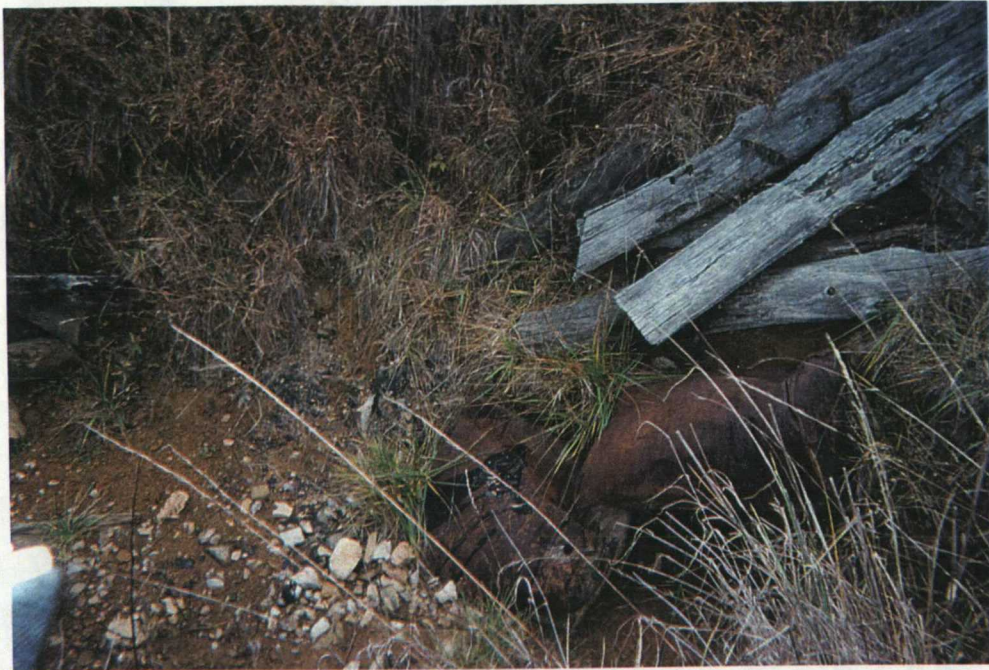
NRSD PHOTO 15: Closeup of wood and drum debris in stream.

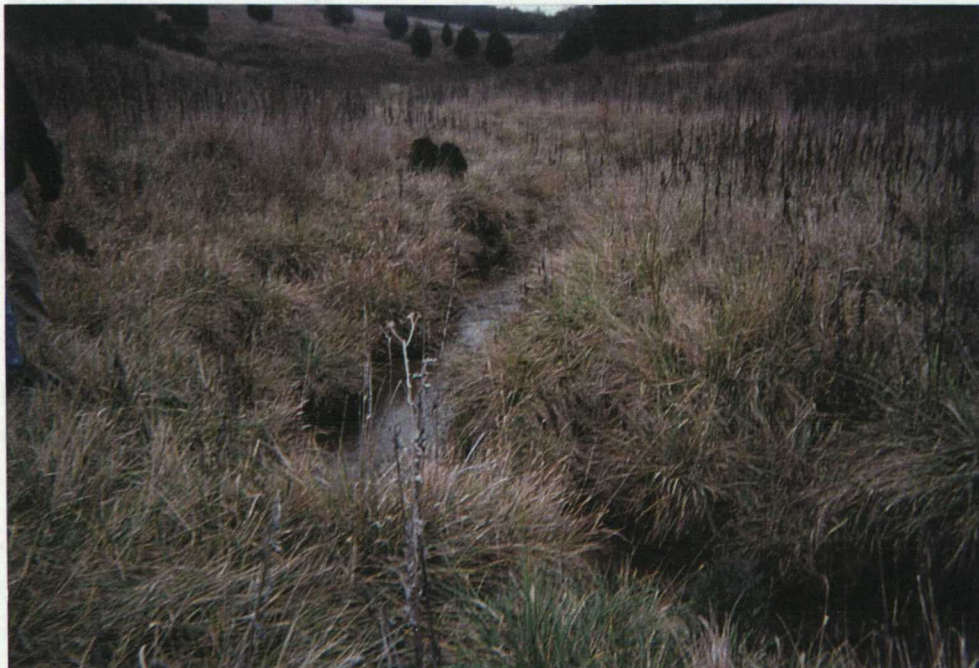
The accompanying photographs of the stream depict the debris. This north branch of the stream appears to originate on the facility property and drains into the main branch. Above the confluence approximately 4,000 feet is the former sewage treatment plant. The field team concluded field work at Area G and returned to the RAAP headquarters building.

NRSD PHOTO 16: Confluence of debris containing stream with stream branch draining from abandoned sewage treatment plant.

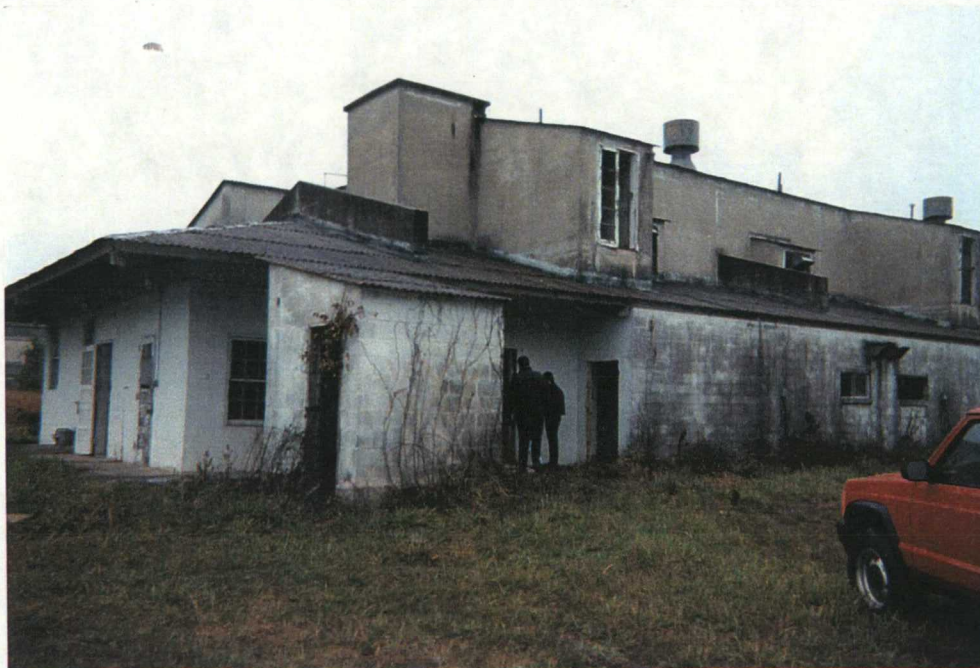
NRSD PHOTO 17: Bag loading Building 445.

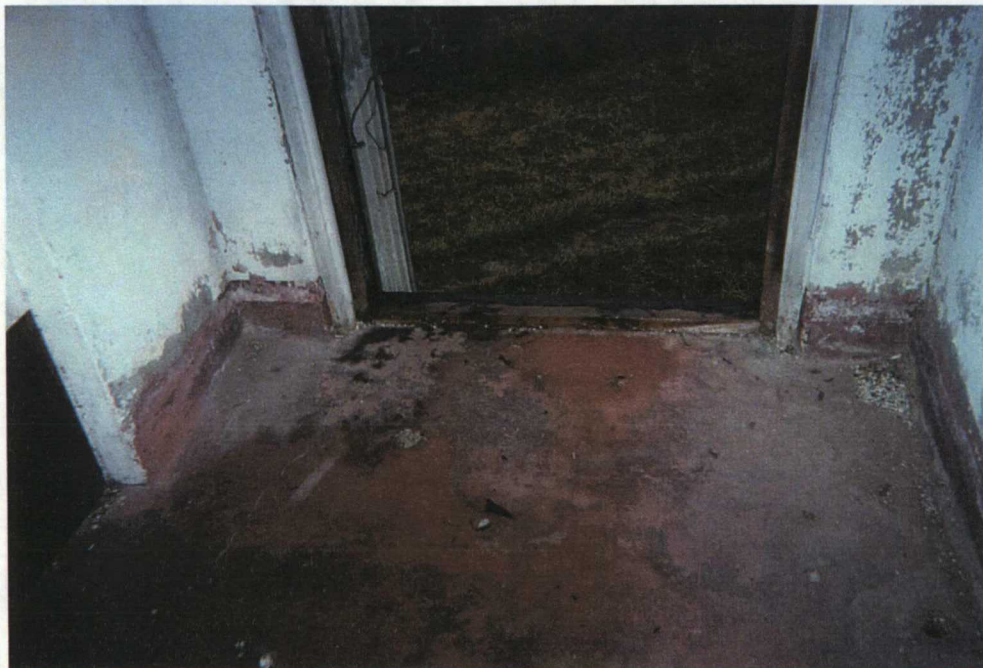
NRSD PHOTO 18: View from second floor of Building 445.

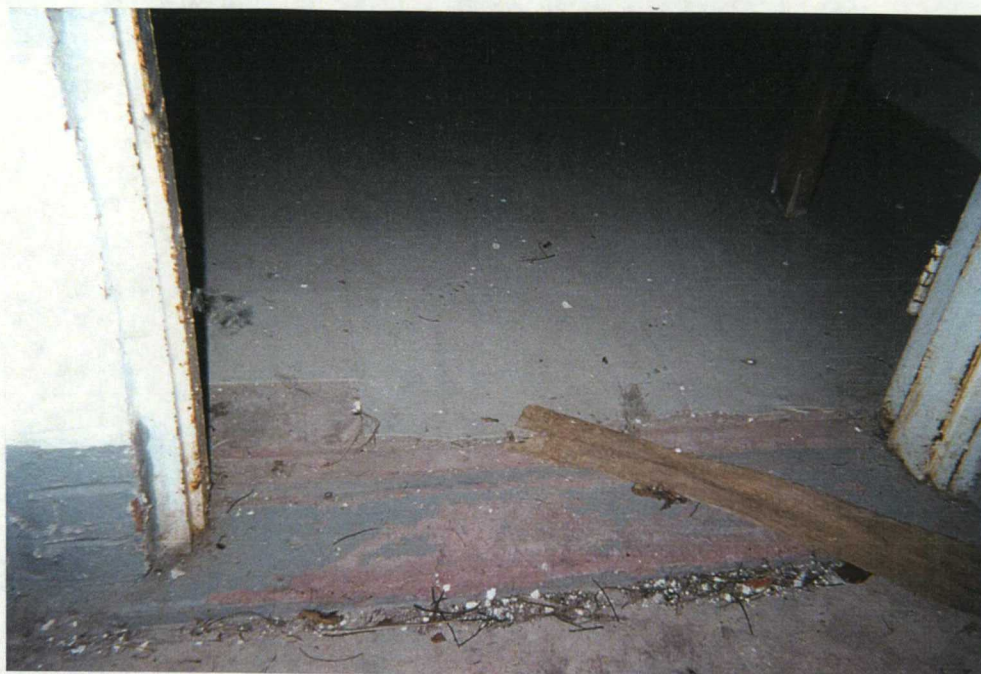
NRSD PHOTO 19: Building 445 - Red conductive floor with gray paint at door entrance. Inside the doorway is linoleum tile floor.

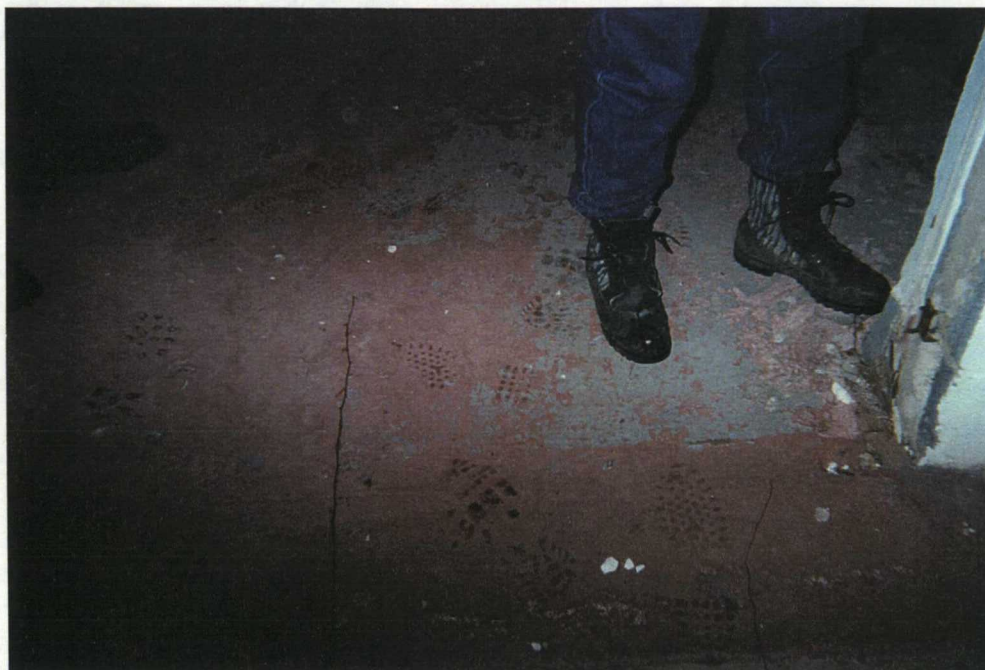
NRSD PHOTO 20: Building 445 - Red conductive floor with gray paint coating.

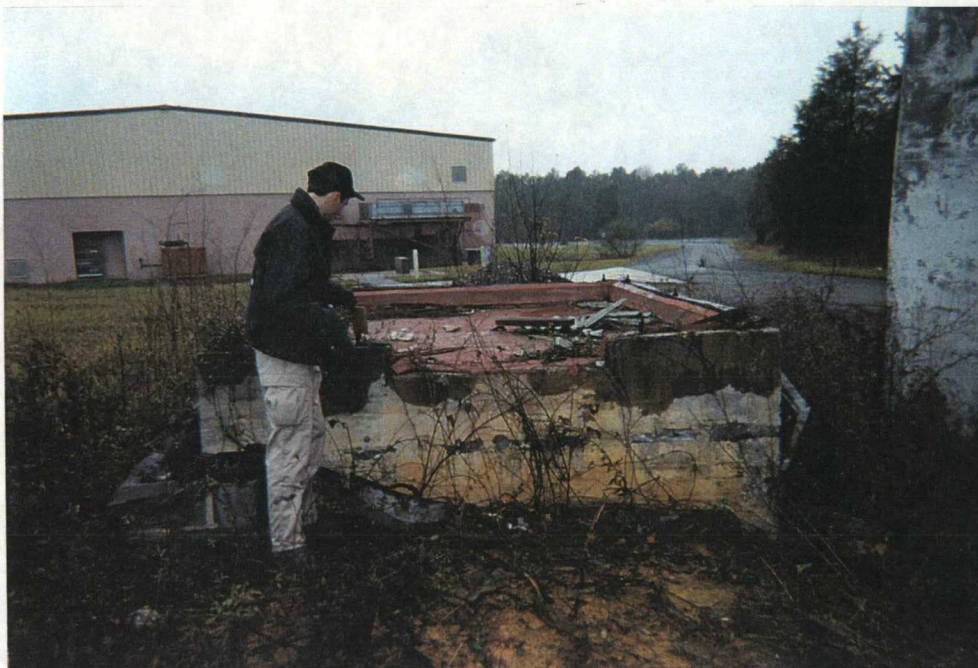
currently uses Building 445 for small quantity storage. Building 453, a former powder magazine, was inspected. Only the foundation remains. A debris pile of transite-type roof material was next to the foundation. Both this material and red conductive floor material appear to contain asbestos-type fibers. Adjacent to these buildings is an electric transformer on a pole. It appears to be old and out of service.

NRSD PHOTO 21: Remnant of smokeless power service magazine No. 453 near Building 445.

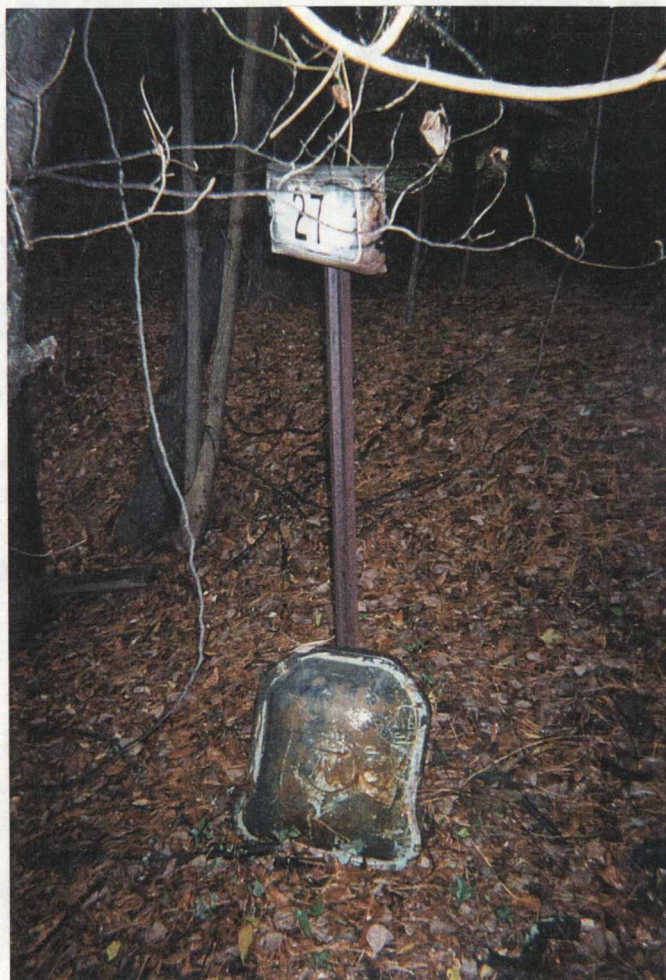
NRSD PHOTO 22:
Location of Transformer No. 27 adjacent to Buildings 445 and 453. Note the transformer's cover at base of sign post.

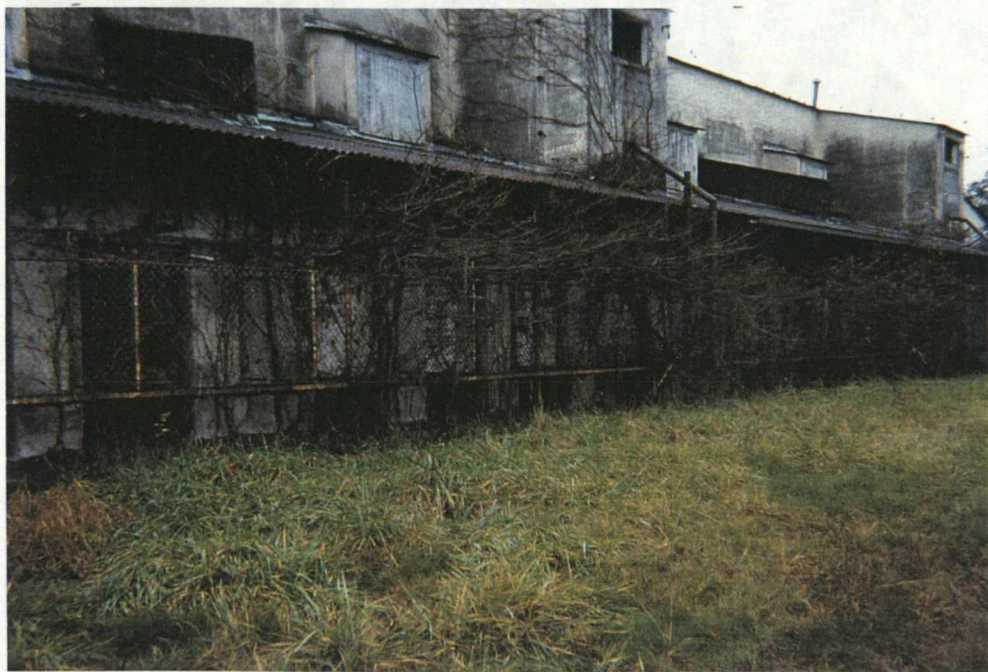
The Old Flow Laboratories complex was then visited. This area (labeled Area H on Figure 1) is located in the former bag loading Building No. 465-A. The laboratory complex was inspected by the field team with a flashlight. Numerous animal cages were seen. In one of the hallways sample bottle labels were found on the floor along with printouts listing lab bottle inventories. One room was found to contain a wood pallet on which approximately 20 to 30 document boxes are piled and sealed with shrink wrap around the entire palletized pile of boxes. These boxes are assumed to represent laboratory operations files. Moving down an adjacent hallway, piles of possible friable, asbestos-containing materials were seen. The team departed from the hallway immediately.

NRSD PHOTO 23: Old Flow Laboratory complex in bag loading Building 465.
Animal cages are located in both the interior and exterior of the building.

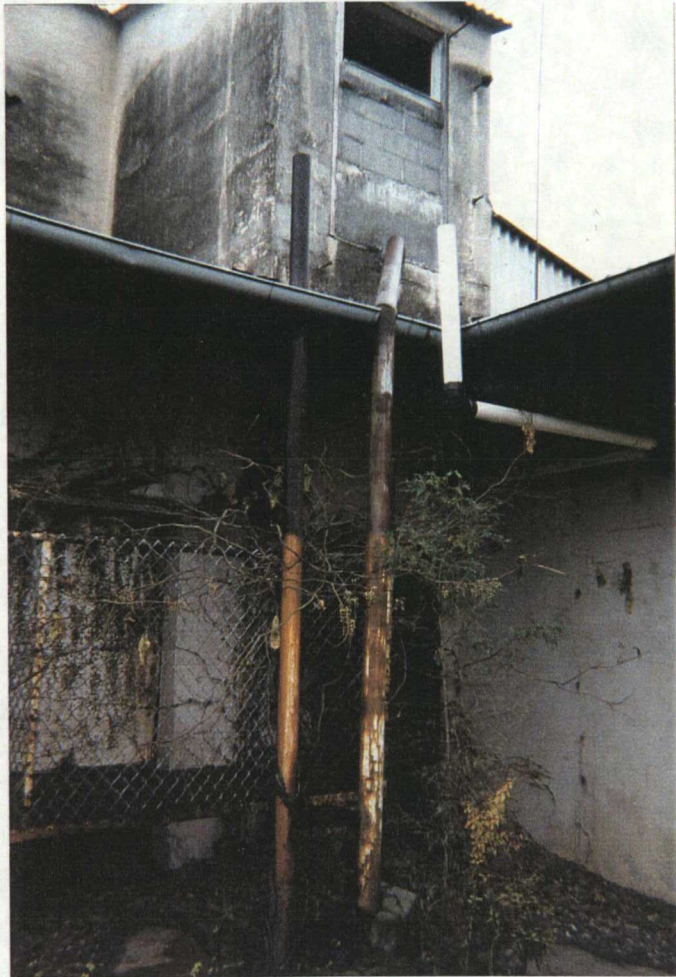
NRSD PHOTO 25:
Building 465 - Probable second
floor wastewater drain to
drainage channel. Probably
drained floors that were hosed
to wash under cages.

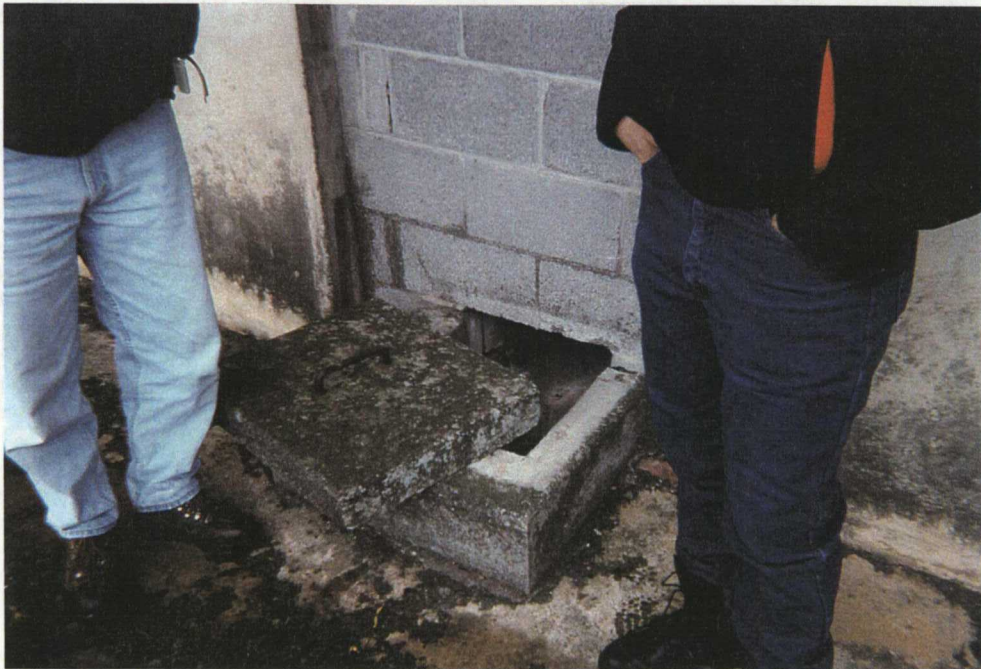
NRSD PHOTO 26: Cement cover for floor drains in
Building 465 (Flow Labs).

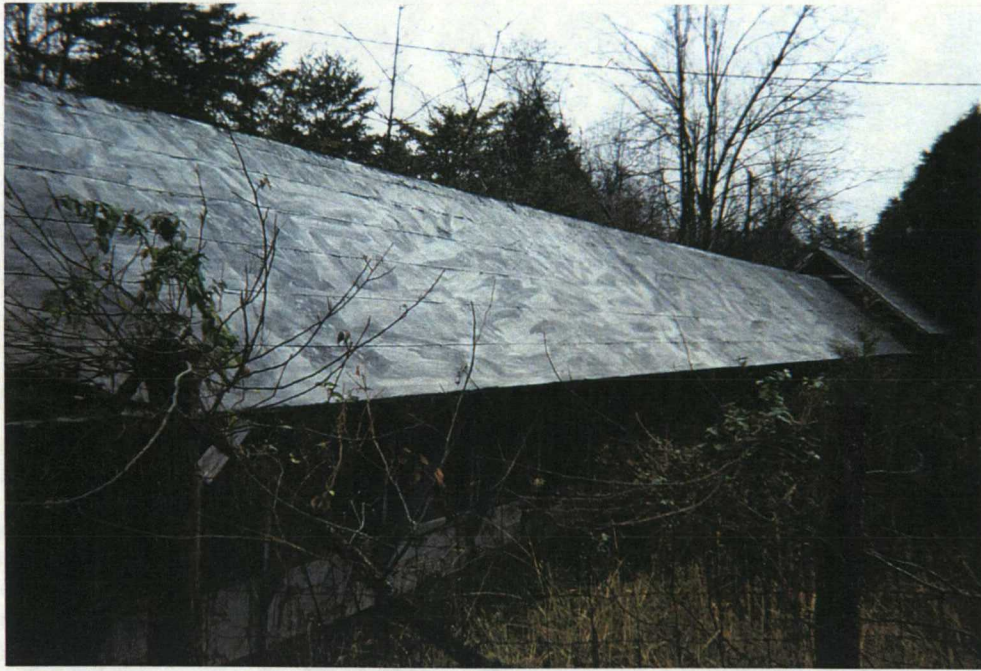
NRSD PHOTO 27: Covered walkway from bag loading Building 465 to shipping magazine.

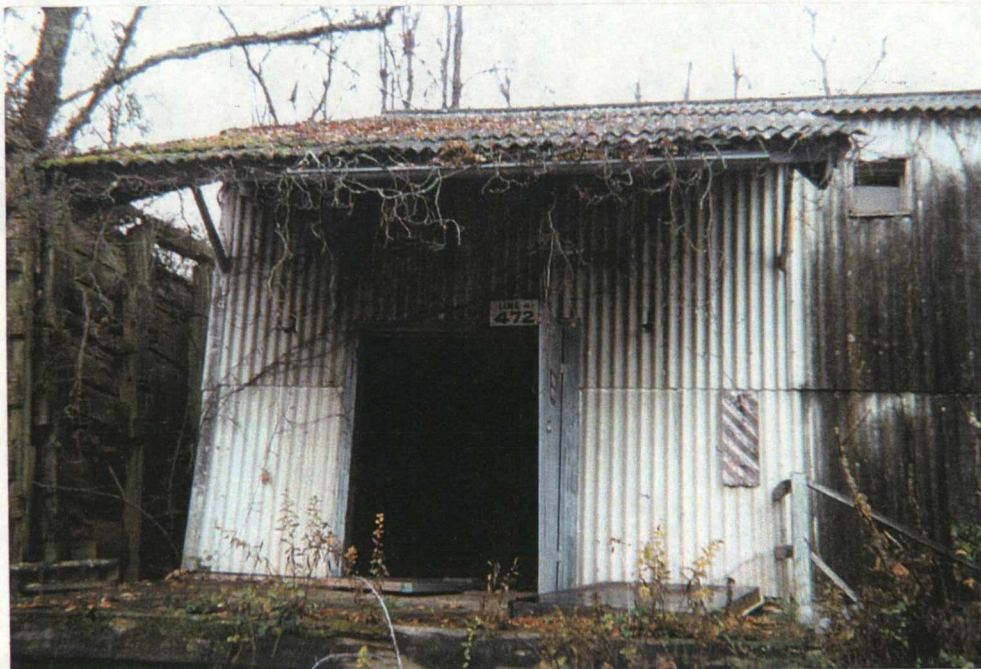
NRSD PHOTO 28: Shipping magazine 472.

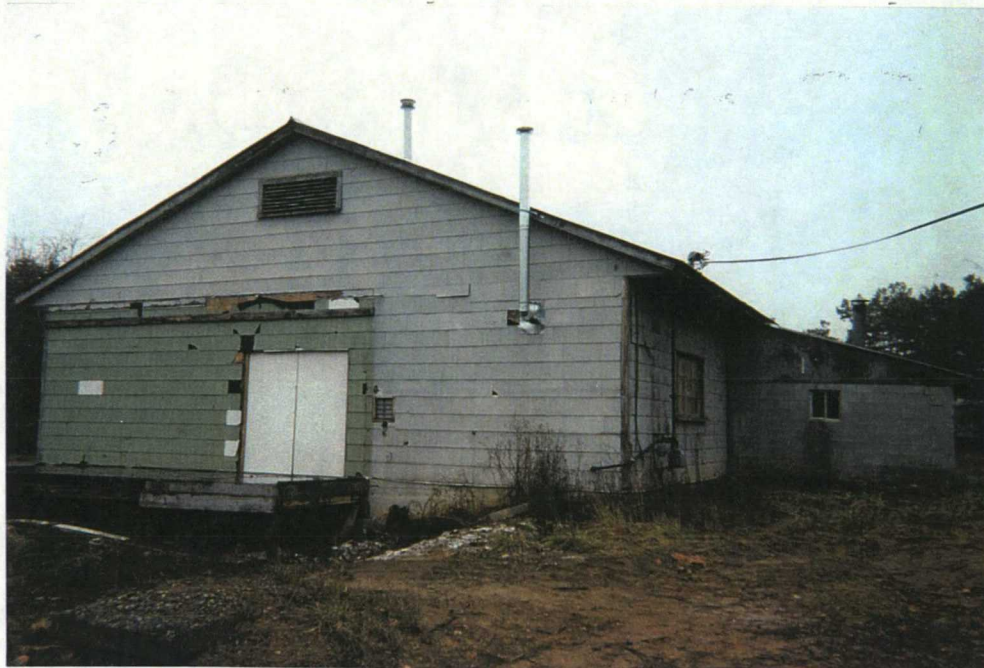
NRSD PHOTO 29: Building 8516.

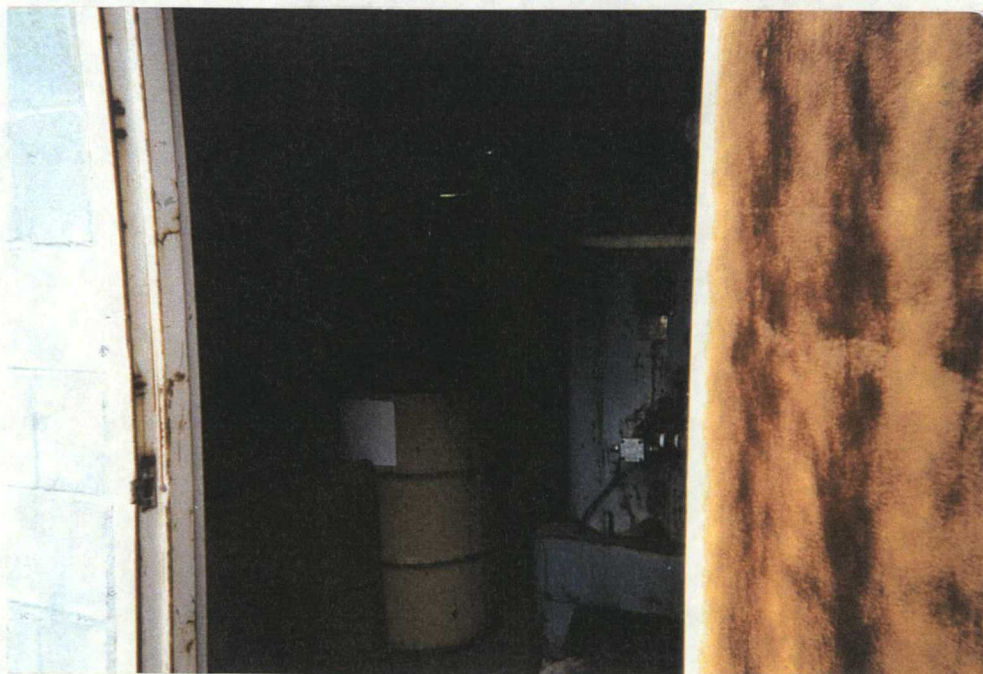
The various buildings in Area H were toured. These included the three service and shipping magazines (Buildings 471, 472 and 473). An adjacent Building No. 8516 was also inspected. It was noted to be in apparent current usage. One drum, labeled flammable, was observed in an open doorway. The entire Area H contains a variety of loading buildings (2), shipping magazines (3), igniter service magazines (2), warehouses (2), canteen (1), boiler house (1), along with transformers and overgrown areas along pathways where various debris, including drums were seen. A focused walking survey throughout this area, taking distance measurements, would provide a good understanding of a complex area that served a variety of functions.

NRSD PHOTO 30: Flammable drum at Building 8516.
